**FINAL REPORT  
SEPTEMBER 2004**

**REPORT NO. 04-16**

**44" x 40" METAL PALLET WITH METAL  
ADAPTERS, CARTRIDGE, 25MM, PA125 METAL BOXES,  
MIL-STD-1660 FIRST ARTICLE TESTS**

The U.S. Army Defense Ammunition Center (DAC), Validation Engineering Division (SJMAC-DEV) conducted First Article Tests in accordance with MIL-STD-1660, "Design Criteria for Ammunition Unit Loads" on the 44" x 40" Metal Pallet with Metal Adapters, Cartridge 25MM, PA125 Metal Boxes manufactured by Choctaw Manufacturing and Development Corporation (CMDC), from Hugo, Oklahoma. Six sample test units were tested. The test units were loaded with a unit load of 2,565 lbs each. The tests accomplished on the test units were the stacking, repetitive shock, edgewise-rotational drop, incline-impact, sling compatibility, forklifting, and disassembly tests.

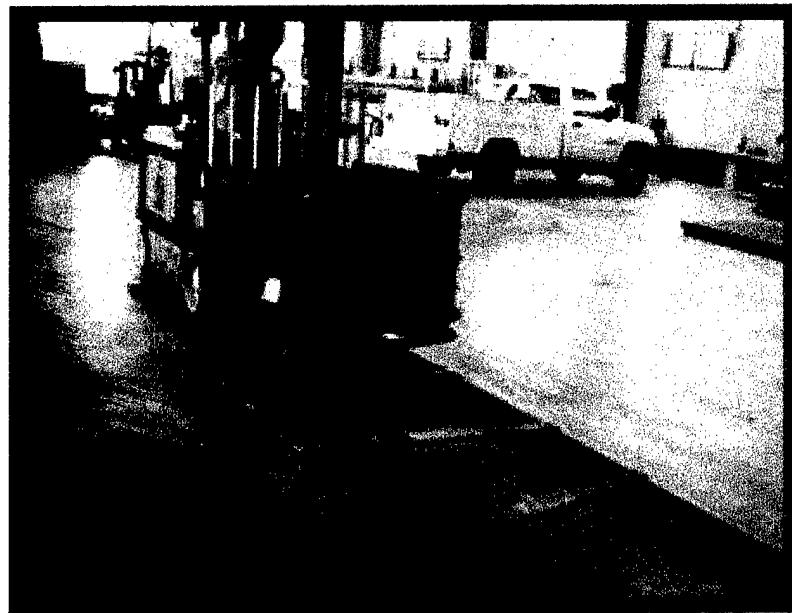
**Photo 11. Test Setup for Forklifting Testing.**

5. **FORKLIFTING TEST.** Test Unit #1 was lifted from the end of the pallet on the forks of the forklift truck and carried over the hazard course two times with no damage or instability noted. The test unit was lifted from the opposite end of the pallet and the above steps accomplished with no problems encountered. (See Photo 11 for the test setup).
